PREPARED FOR  
**JETMASTER (VIC) PTY LTD**

**THERMAL CLEARANCE TESTING OF THE VISIONLINE  
TAURUS INBUILT AND ZERO CLEARANCE BOX**

Report Number: ASFT20016-1  
Issue date: 28 May 2020

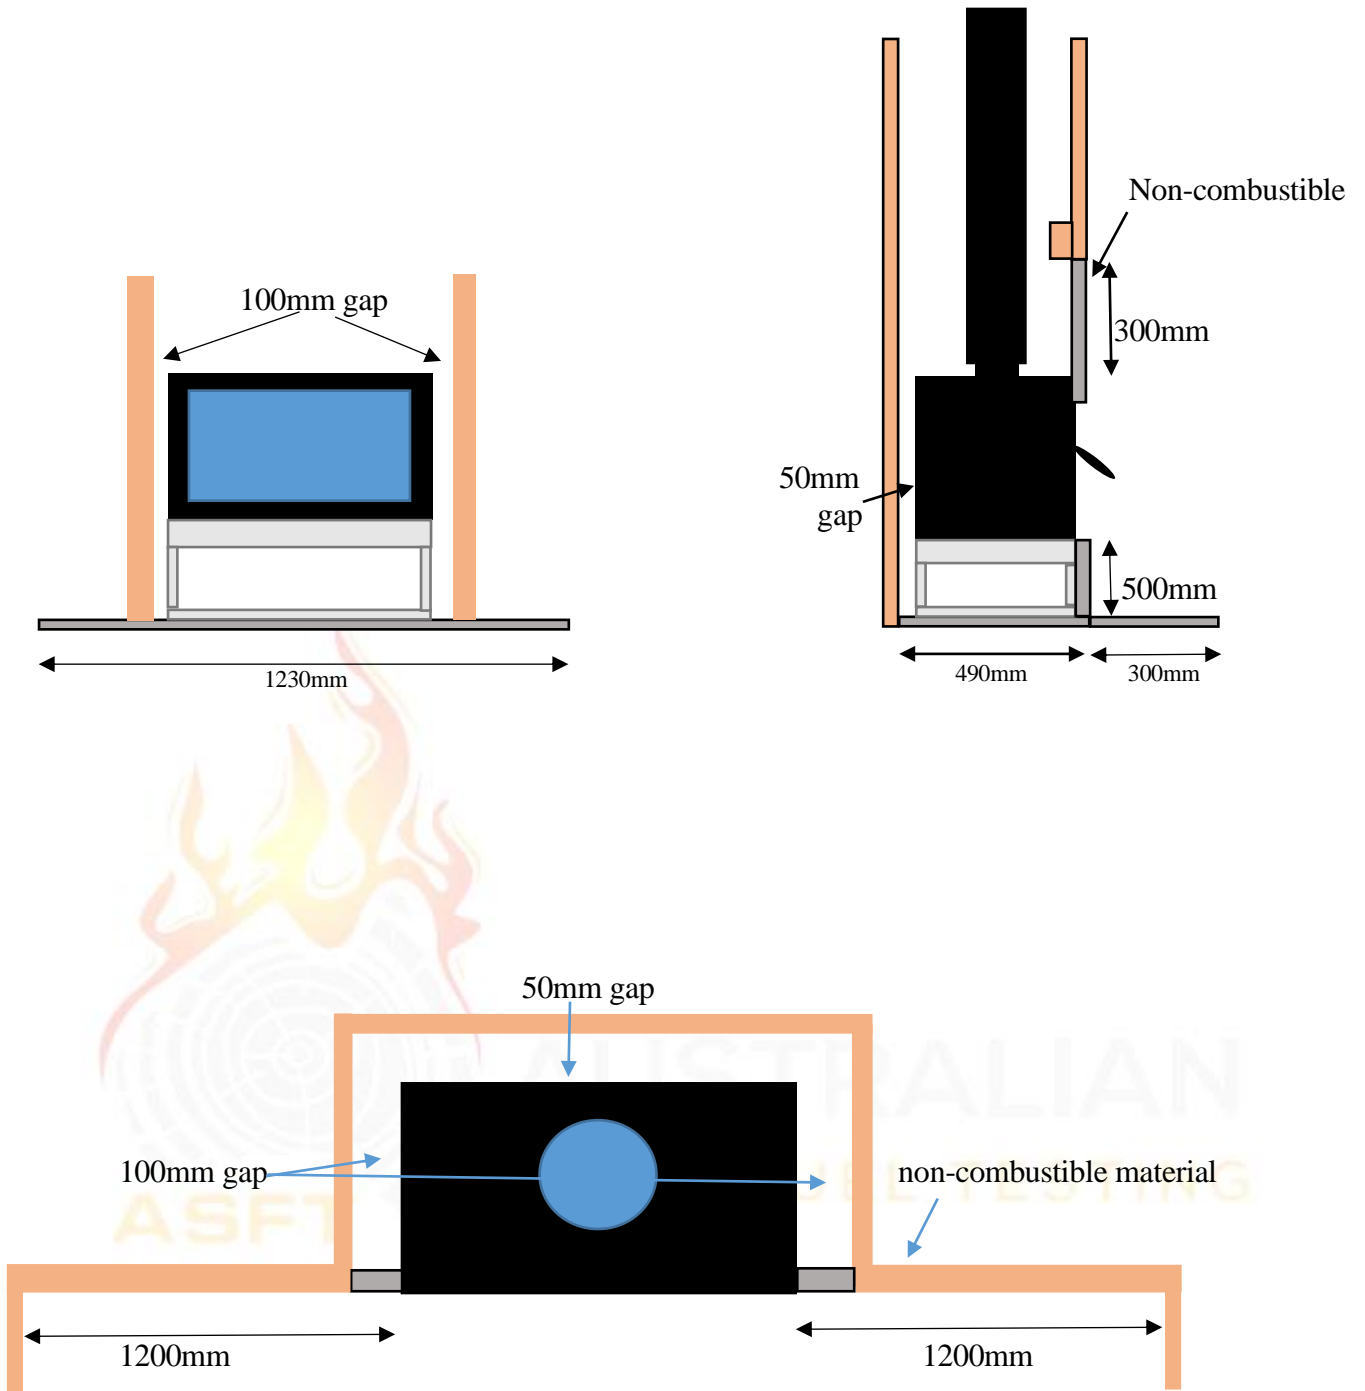
Figure 1 – Clearance Diagram

The appliance and Flue Combination should be installed at the following clearances:

- The mantle shelf and mantle upright clearances was not tested and should be installed as per clause 3.4.1.3(b) of AS/NZS 2918:2018
- Flue ceiling penetration must have a 50mm air gap in all directions around the outer casing of the from combustibles.

- The outer casing of the flue (12") must be raised 65mm above the zero clearance box
- The inner galvanised casing of the flue (10") must be vented into the zero clearance box outer skin and be sealed to prevent venting into the enclosure

- The front wall of the enclosure must be made of non-combustible material to a height of 300mm above the zero box from the hearth and must extend to 100mm either side of the zero box.

- 300mm from the top of the Zero Clearance box to the first internal wall noggin above the front of the appliance.
- The Zero clearance box as tested must have air gaps of 8mm above the appliance and 3mm on both the sides of the appliance.

- Combustible material/rear wall of the enclosure must be a minimum of 50mm from the rear of the appliance zero clearance box
- Combustible material/side wall of the enclosure must be a minimum of 100mm from the side of the appliance zero clearance box

The VisionLINE Taurus Inbuilt and Zero Clearance box with a Wildcat 6” triple skin flue kit, conforms to the requirements of Australian/New Zealand Standard 2918:2018, with respect to floor and Zero enclosure internal surface temperatures, when tested in the test position shown in Figure 1 of this report in accordance with Appendix B of AS/NZS2918;2018.
